TECHNICAL MEMORANDUM FROM

To: Briana Swette, Pale Gem, LLC

Date: June 24, 2022

Re: Big Wood River Restoration, Pale Gem LLC Project

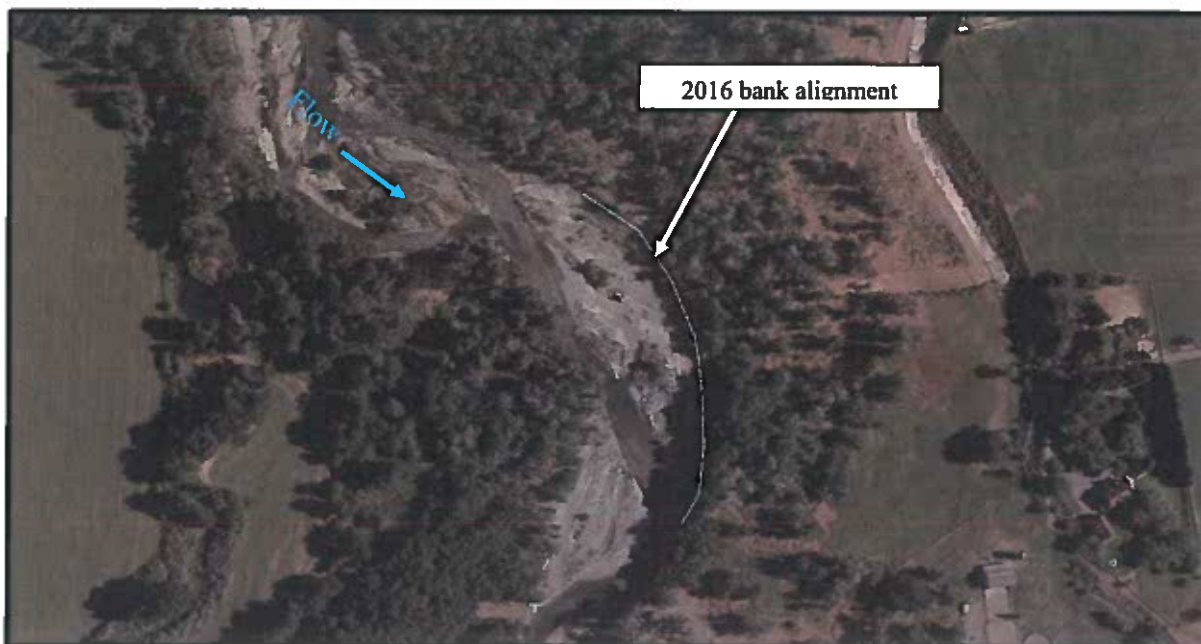
There has been severe lateral channel migration through bank erosion in the project area in recent years. A review of aerial photography indicates that there has been over 200 ft of lateral channel migration since 2016, the majority of which occurred during the flood of 2017 (Figures 1 and 2). The resulting geomorphic conditions in the project area can be described as highly unstable with an expansive braided channel form. The width of the active channel area is approximately 850 ft in the project area. Note the extensive loss of riparian vegetation in Figure 2. Currently, the main flow path is along the western side of the channel for most of the Pale Gem LLC property crossing over to the eastern edge directing flows towards a failing rock barb structure near the southern end of the property. Two large mid-channel log jams that formed

Figure 1. Aerial imagery from July 2016 depicting channel conditions in the project area (Source: Google Earth).

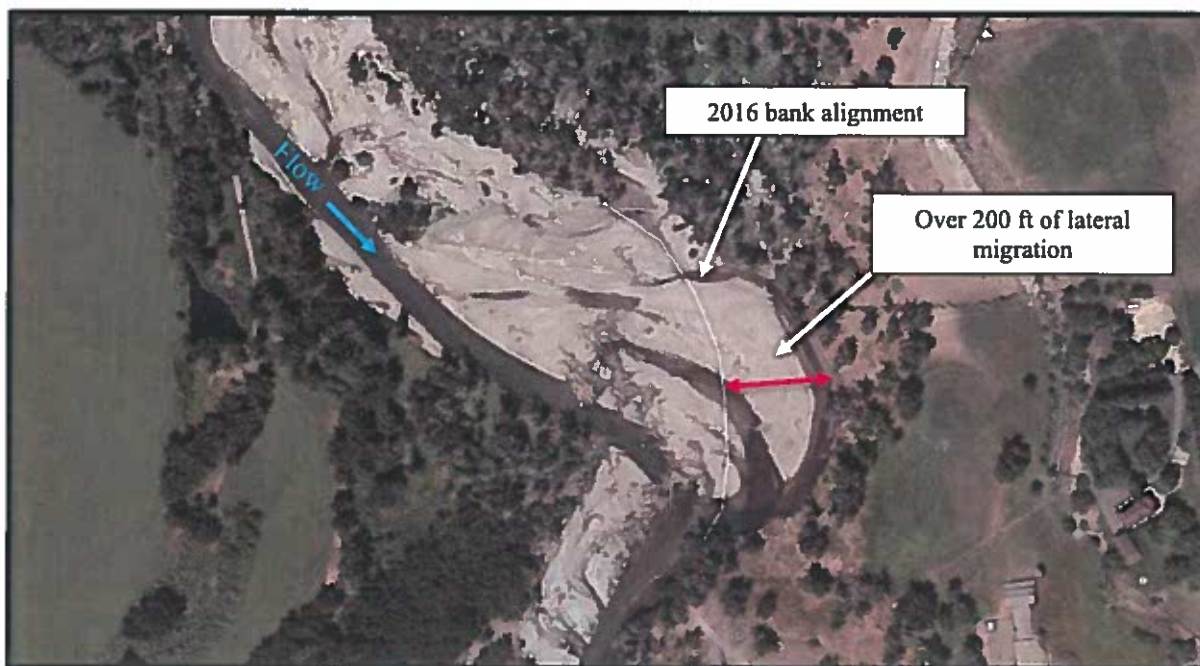
Figure 2. Aerial imagery from July 2017 lateral channel migration and log jam formation (Source: Google Earth).

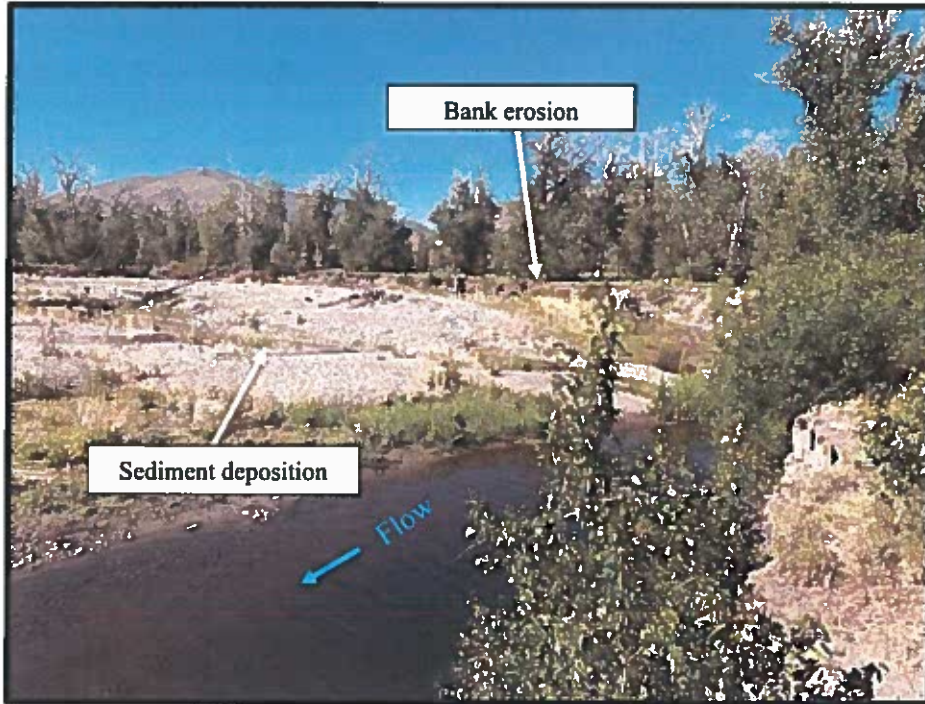
Figure 3. Photograph depicting bank erosion in the project area (view from the south)

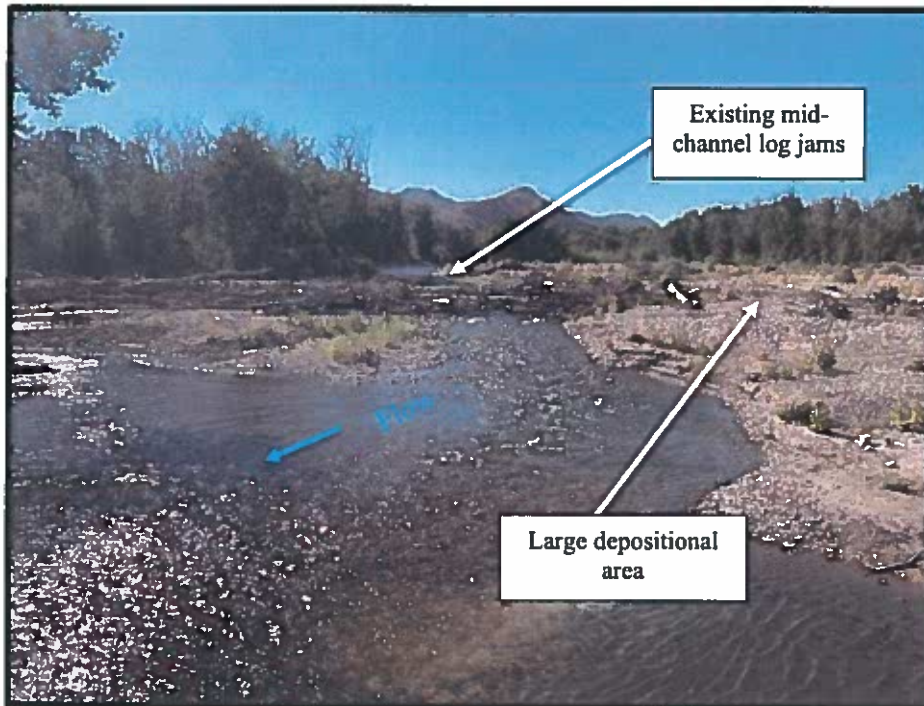
Figure 4. Photograph depicting existing log jams and channel conditions in the project area (view from the southeast)

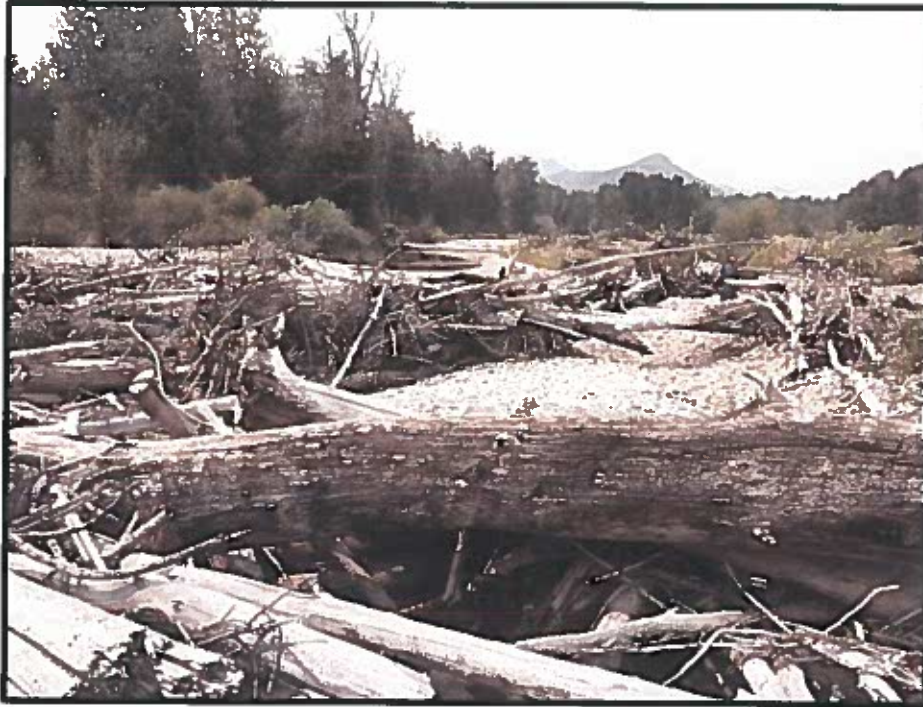
Figure 5. Photograph depicting large mid-channel log jams in the project area (view from the north).

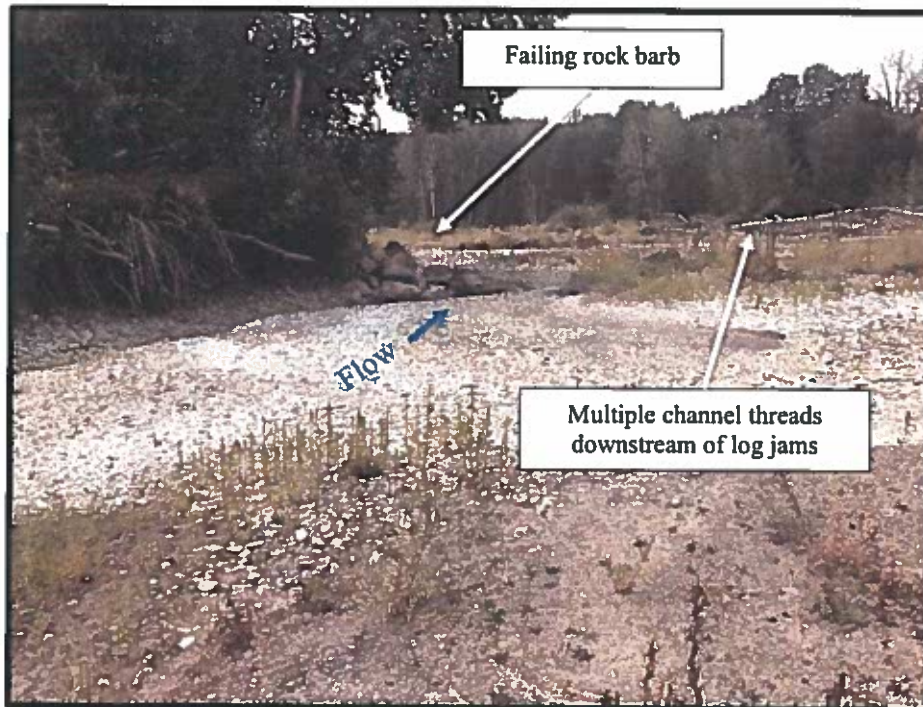
Figure 6. Photograph depicting a failing rock barb near the downstream end of the project area (view from the northeast).

The proposed restoration design plan for the project is to increase the stability of the river bank on the Pale Jem LLC property with restoration treatments incorporating revegetation, bioengineering, bank grading, and large wood structures. The project design plan also includes treatments to repair a failing rock barb structure, including scour protection, and construct a rock toe in the area with increased bank erosion risk. Revegetation would occur along the toe of the bank and in the river adjacent to the bank to add roughness and promote increased stability. Bank grading would occur in specific areas where the current near vertical bank slope is a safety concern for the landowner with minimal impact to mature overstory vegetation.

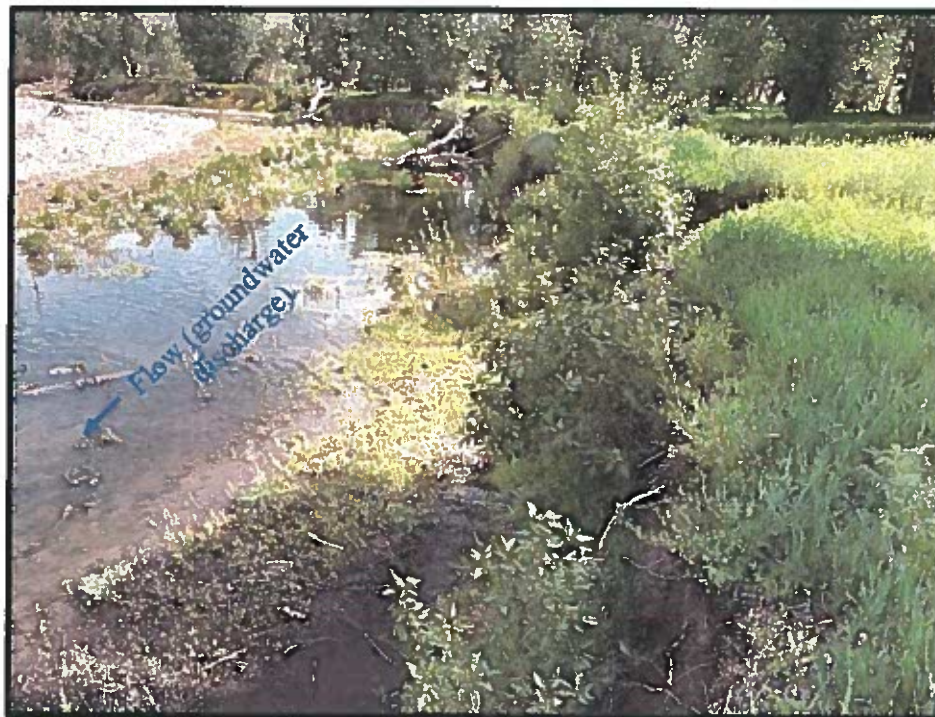
Figure 7. Photograph depicting vegetation establishment along the bank toe (view from the south).

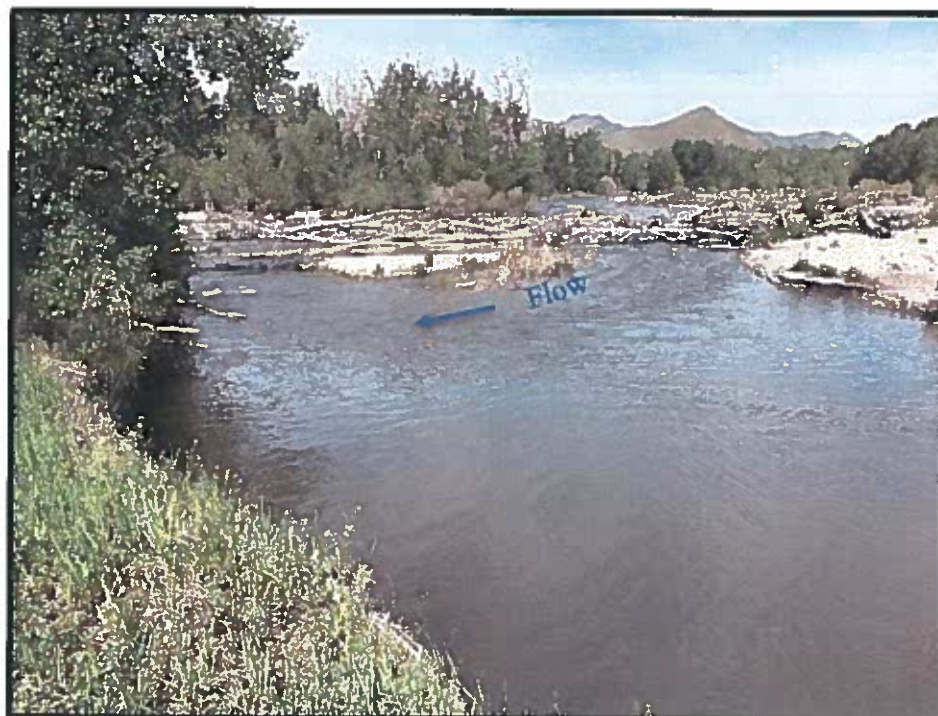
Figure 8. Photograph depicting high bank erosion hazard area with impinging flows (view from the southeast).

The proposed deflector log jam structures were evaluated for stability and scour. The scour evaluation included general bed scour in addition to local scour developed by the proposed jam configurations. The rock toe treatment for the high bank erosion hazard area, shown on Sheet 5 and 7, was designed, and material sized using U.S. Army Corps of Engineers technical bulletins and methodologies that incorporated input parameters of design channel geometry, channel slope, mean and maximum channel depths, flow velocity, and radius of curvature. The rock toe should extend from the bankfull elevation down to the local scour depth of 6 ft below the channel invert elevation, based on potential scour calculations. The rock toe should have a horizontal to vertical slope of 2H:1V with willow cutting bundles installed following the revegetation methods identified on Sheet 8 and described below. The rock toe treatment would tie into the repair of the failing barb at the downstream end of the treatment area. The rock barb repair would include placing scour protection rock to below the calculated potential scour depth to reduce the risk of future erosion and structure damage.
